The Old Cathedral of Viborg

Historical Archaeology of the Easternmost Cathedral of the Swedish Empire*

Aleksandr Saksa and Panu Savolainen

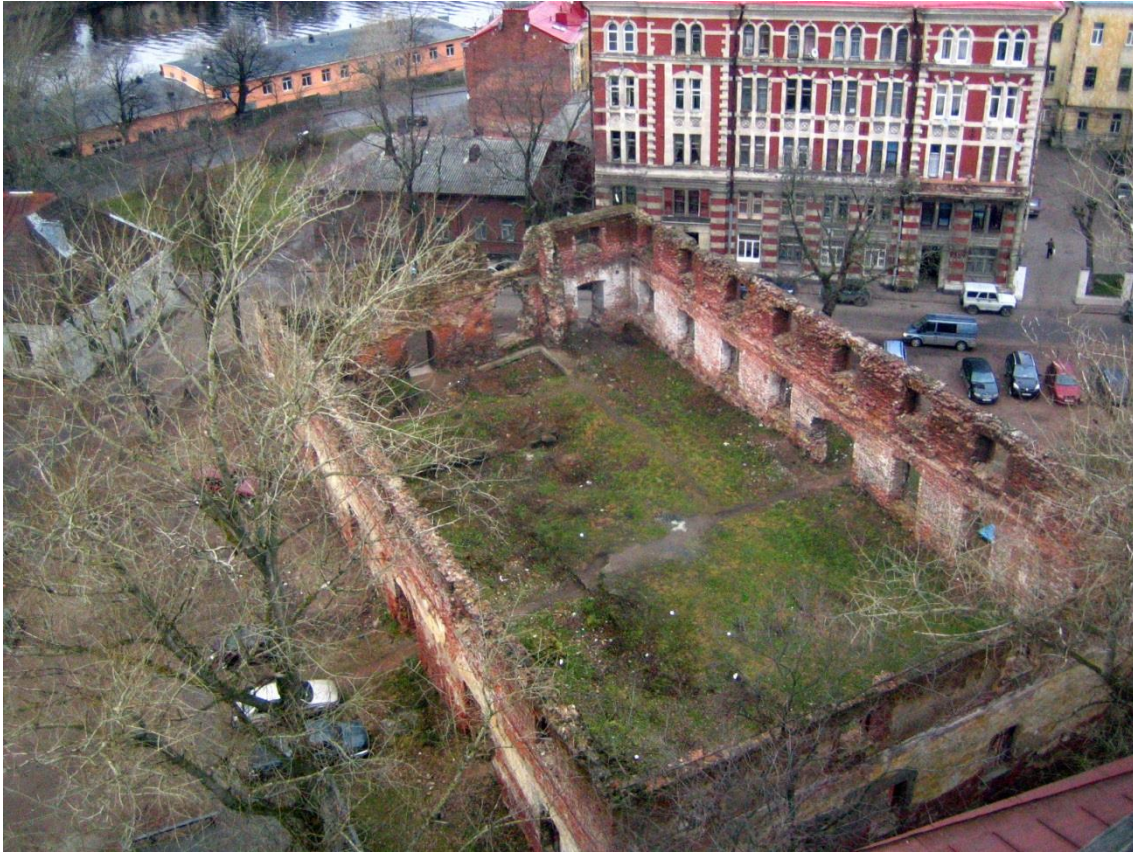
Fig. 2. The former medieval Parish Church and the Old Cathedral of Viborg seen from the belfry in 2011. Photo: Panu Savolainen.

shifts of religion render the trans-religious past of the sanctuary relatively exceptional even on a global scale (Fig. 2).

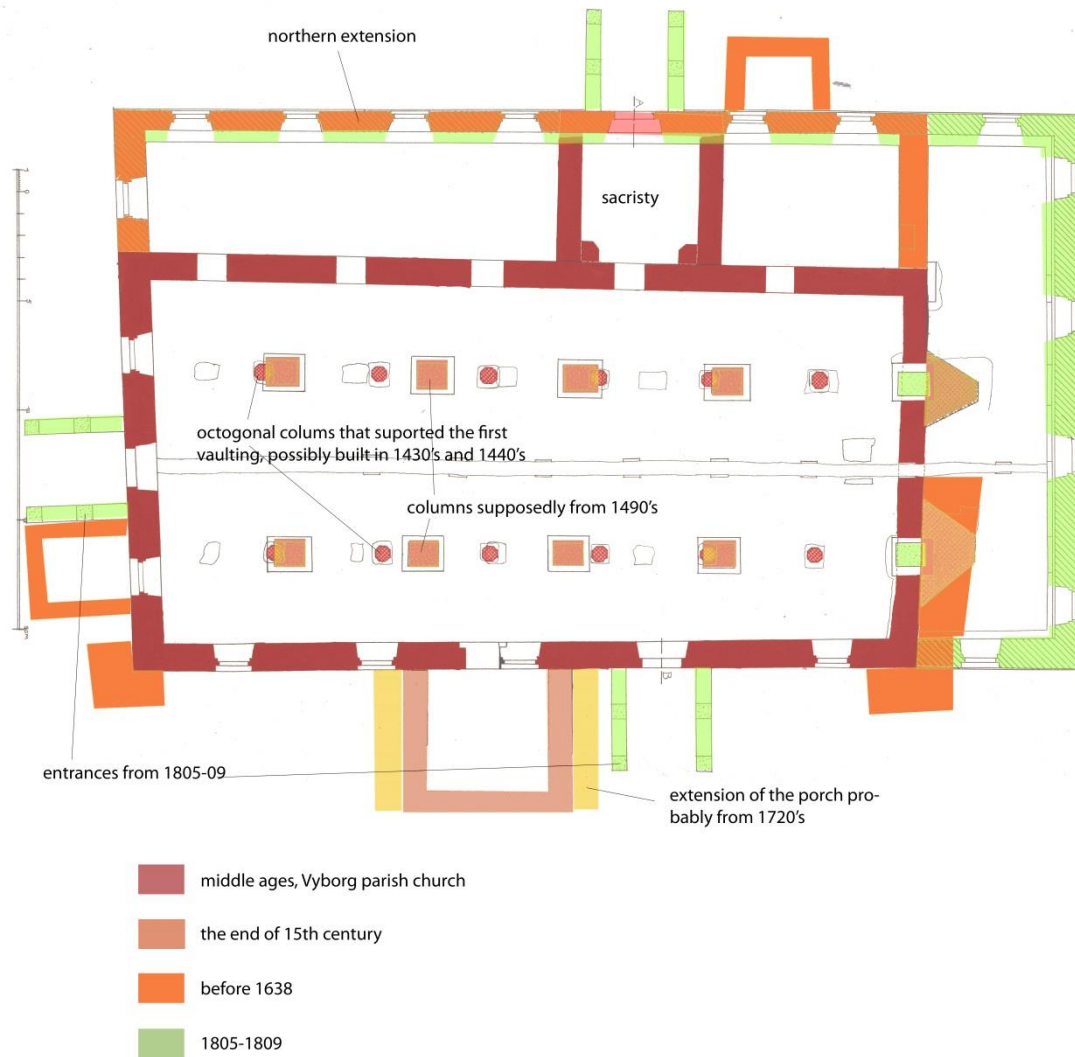
Fig. 7. The chronology of the construction of the old cathedral. Map: Panu Savolainen.

Numerous skilful master builders worked in Viborg from the 1560s to the 1590s when the eastern fortification was constructed.³⁰ Also after the fire of 1627 a German master builder was commissioned to lead the renewal of the town plan and to supervise the construction work in public buildings.³¹ The documents of the town court from the late 1620s and the early 1630s do not give any further information on any construction works going on in the cathedral. The dating of the northern extension remains thus unclear (Fig. 7).

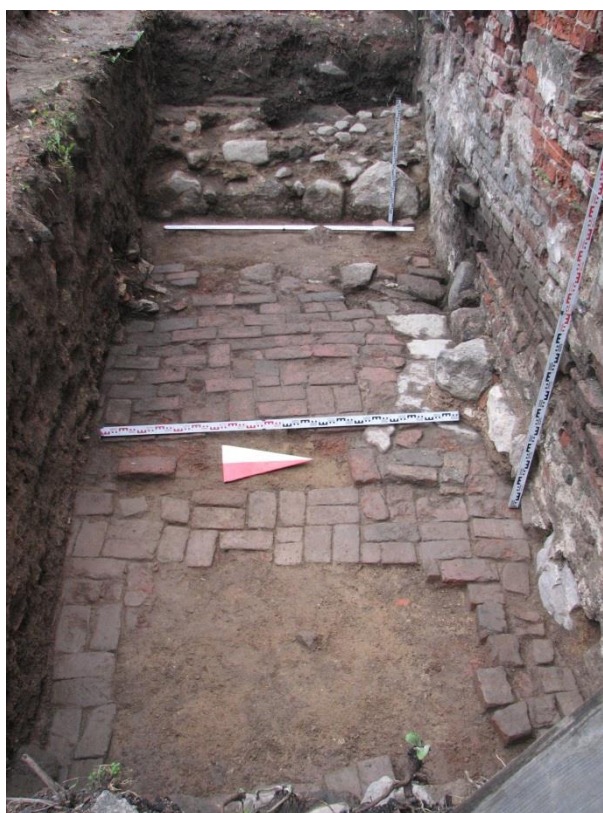
Fig. 9. Trench A, a brick pavement, and the side walls of the porch, supposedly from the 1720s. Photo: Aleksandr Saksa.

Beneath the modern layers, the trench A revealed the sidewalls of a porch and a brick-made pavement (Fig. 9). On the pavement, Russian coins from 1718–1725 were discovered, and beneath the pavement, a Swedish coin from 1635 was unearthed.³⁵ Therefore the pavement probably dates to the years when the church was transformed into a Russian Orthodox sanctuary at the beginning of the 1720s. Beneath the sidewalls, vestiges of a previous porch were uncovered.

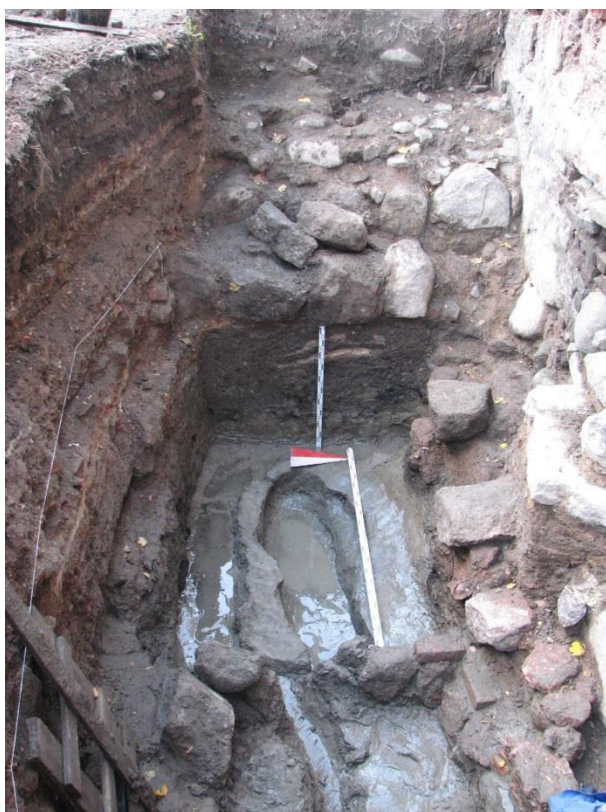
Fig. 10. Trench A, late medieval burials on the site of the later porch. Photo: Aleksandr Saksa.

The layers below the brick pavement consisted of several mixed layers with indications of fire. These layers contained mixed human bones, probably in a secondary context, and they were fragmentary and showed no signs of intentional deposition. The lowest units were intact, and several well-preserved burials were discovered, even the coffins were partly preserved (Fig. 10). A

radiocarbon date from one of the pieces of birch bark, taken from the same context as one of the coffins, gave the most probable dating to 501±32 BP. The stratigraphy suggests that the burials were older than the porch.³⁶ On the basis of the radiocarbon dating, it is probable that the porch was constructed during the last decades of the Middle Ages or even later. There is a written account of about 1,700 bricks that were used in building the porch (Sw. *kyrkofarstugan*) in 1573.³⁷
